**INSPECTION REPORT FOR
Asbestos-Containing Building Materials, Lead-Based Paint,
Polychlorinated Biphenyls, and Mercury Containing
Components**

**Former Wayland Highway Department Garage
195 Main Street
Wayland, Massachusetts**

Project 16487

December 1, 2016

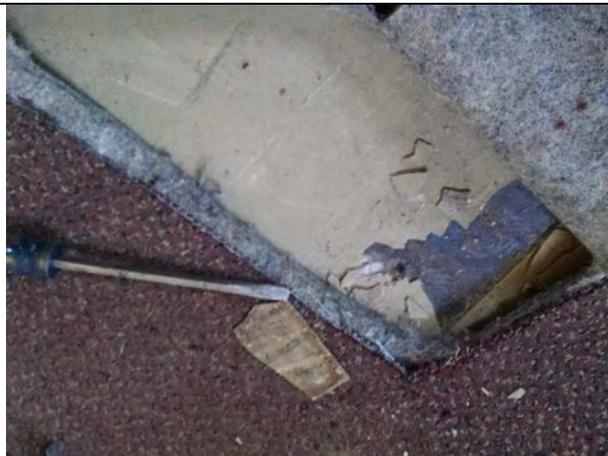
Table 1 • List of Materials Testing Positive for Asbestos			
Type of Material	Location	Quantity	Sample number
Brown flooring/leveler and associated mastic on concrete	1 st floor front office underneath red carpeting	150 sf	03A
Gray pipe insulation debris	2 nd floor storage above reception area. In wall at floor level below shelves	1 lf	06A
Black rolled roofing and associated roofing felt	Main upper roof; including original building	8,500 sf	19B
Black chimney flashing	Original roof	15 sf	20A

Asbestos-containing flooring/leveler under carpet

1. Both friable and non-friable ACM were identified at the site. ACM that will be impacted by renovation or demolition work must be removed, by qualified asbestos abatement personnel, before they are disturbed. SWA recommends that this work be conducted in accordance with a project design as prepared by a licensed Asbestos Abatement Project Designer. *This report is not intended for use as an abatement design.*

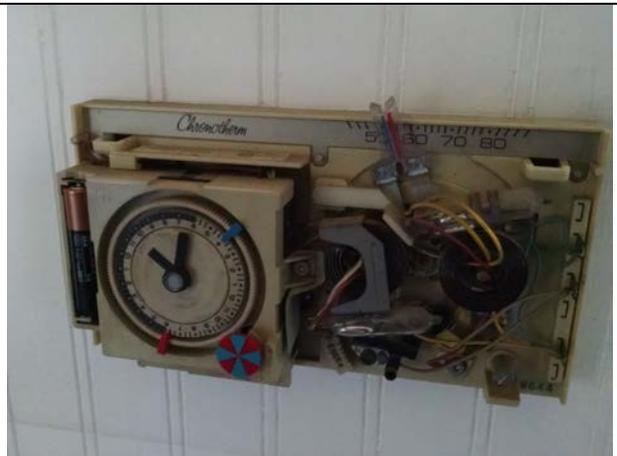
SWA estimates that there are 200 (4') and 5 (8') fluorescent bulbs that would require recycling. Four heat regulating thermostats with a total of seven associated mercury tubes were observed in the space.

Mercury thermostat

1. Prior to being impacted, all fluorescent light bulbs and any heat regulating thermostats with associated mercury tubes must be collected and properly packaged for disposal or recycling in a facility permitted to accept mercury containing waste.

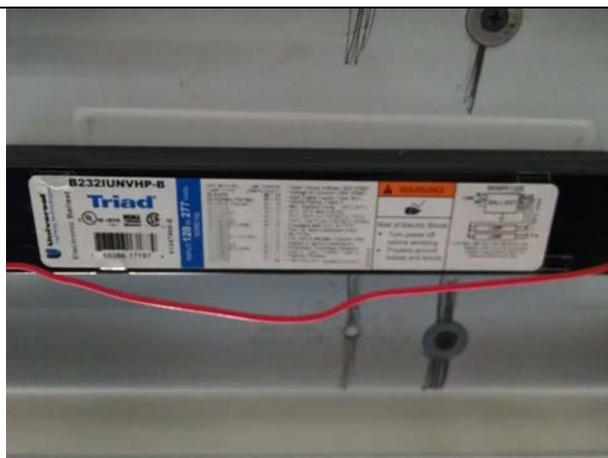
Ballasts representative of the large majority of light fixtures contained the "No PCBs" wording on the affixed labels and therefore are assumed to not contain PCBs in their capacitor oils. However, all individual ballasts must be inspected for the "No PCB" wording on affixed labels to determine proper disposal/recycling requirements.

Non-PCB ballast

1. Prior to renovation or demolition all ballasts should be inspected for the "No PCB" wording on the label to determine appropriate segregation and recycling requirements. The ballasts that do not contain the "No PCBs" wording on the affixed label are assumed to contain PCB oils and must be segregated for proper disposal/recycling.
2. Of those materials sampled and analyzed none were determined to contain PCBs. Therefore, there are no special handling and or disposal requirements relative to PCBs in building materials at this site..

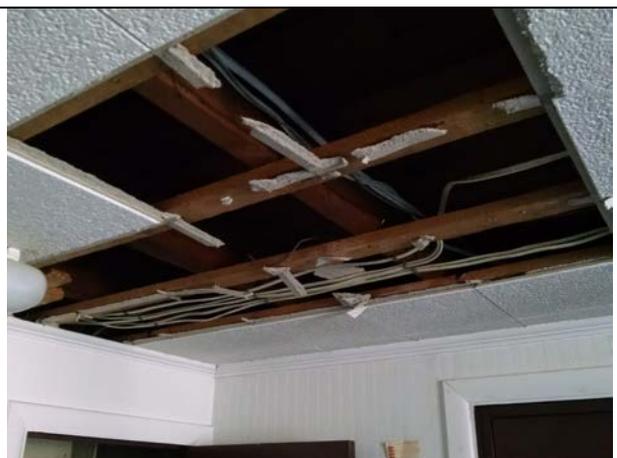
No suspect materials above ceilings

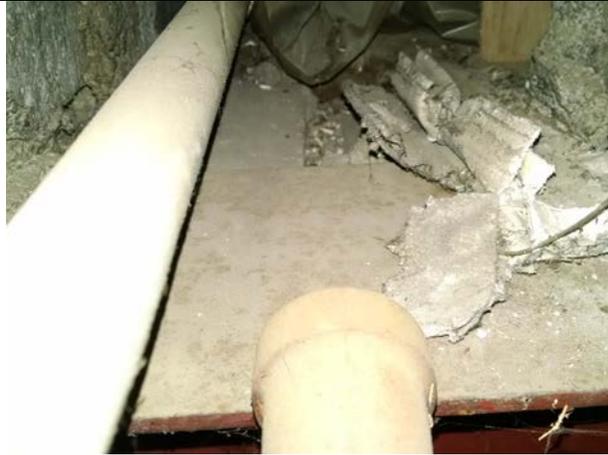
Asbestos-containing pipe insulation debris

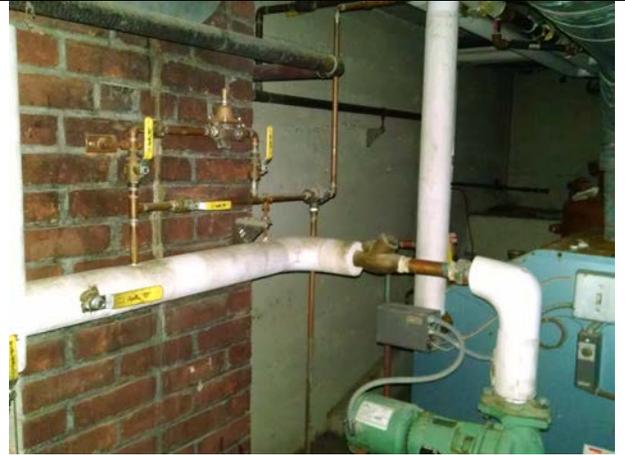
Fiberglass insulation in boiler room

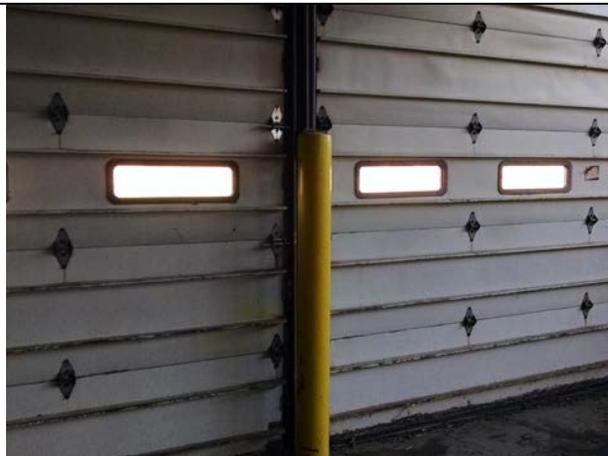
Lead paint on safety posts

1. Limited lead containing materials were identified at the site. Handling or impacting materials that are covered by LBP may require compliance with the OSHA lead standard. To minimize exposure to airborne dust or fumes, torch burning, cutting, grinding, or similar high impact work on materials covered by LBP should be avoided. Such work would need to be conducted by properly trained workers using appropriate worker protection and engineering controls.

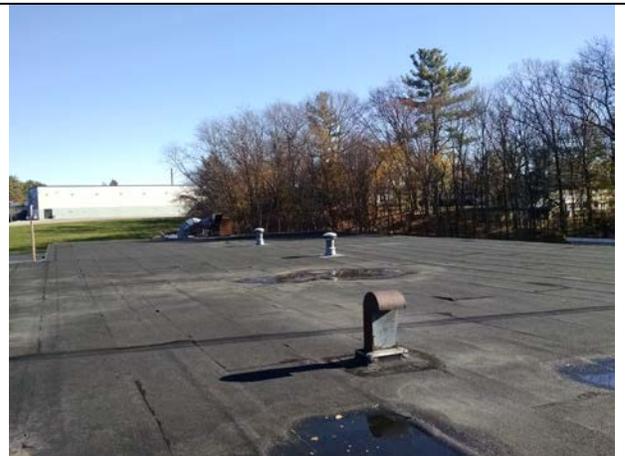
Asbestos-containing roofing on main roof

3. Asbestos-containing asphalt roof materials may be removed by professional Roof Contractors who are trained to handle Category 1 non-friable asbestos-containing roof materials. All work must be conducted in accordance with the requirements of MA DEP 310 CMR 7.15(10). However, the Contractor must submit a notification to the MA DEP 10 business days prior to starting the work. This notification form BWP AQ-04 may be obtained on the MA DEP web site and submitted electronically. Asbestos-containing roof materials may be disposed of in a solid waste landfill as permitted by the MA DEP.

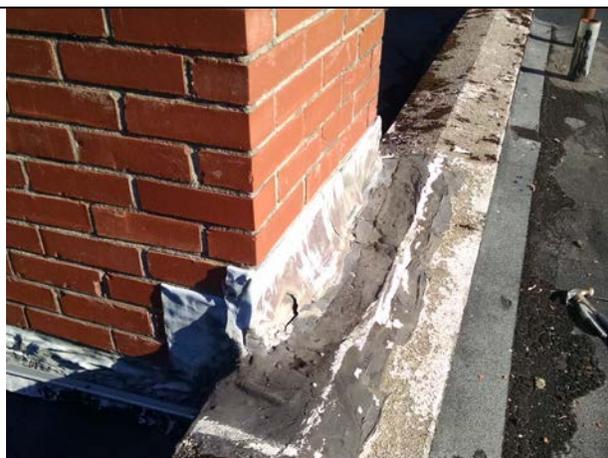
Asbestos-containing tar flashing on chimney

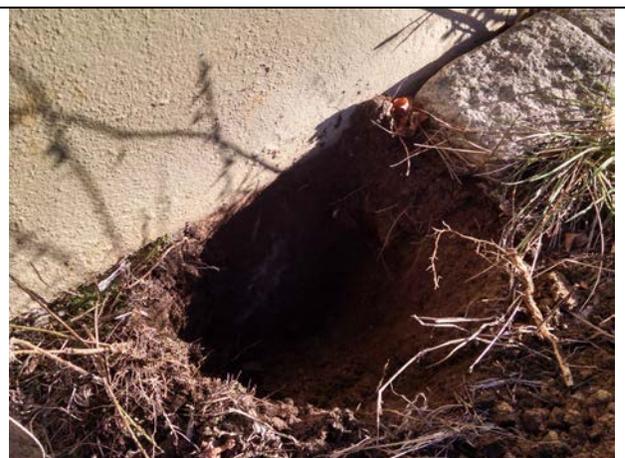
No waterproofing observed on foundation
